Manhole Inspection Summary

Manhole # S35M__021MH

Insp Date: **5/5/09 10:37 AM**

Location Address: **LIGHT ST - IN INTERSECTION**

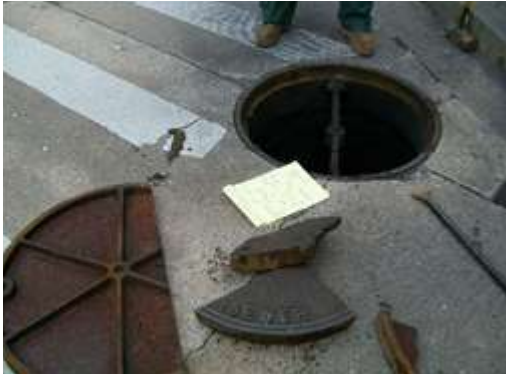
MISC.

CUT OFF COVER TO INSPECT

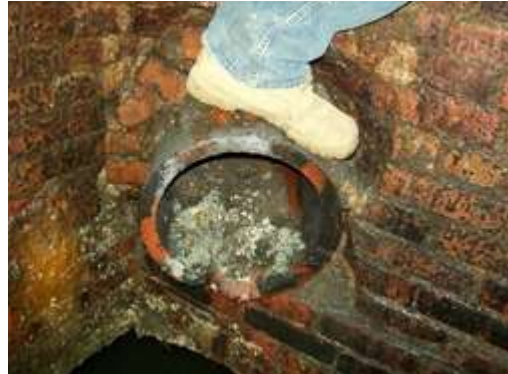
Defect 5

Infiltration: ☐ None ☒ **Joint** ☐ Cracks ☐ Mortar ☐ Roots ☒ **Wall**

INFILTRATION @ BARREL WALL, LEFT SIDE OF PHOTO

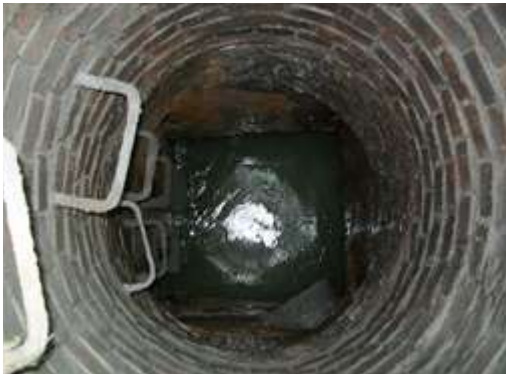
Defect 4

Infiltration: ☐ None ☒ **Joint** ☐ Cracks ☐ Mortar ☐ Roots ☐ Wall

INFILTRATION @ CORBEL/BARREL JOINT

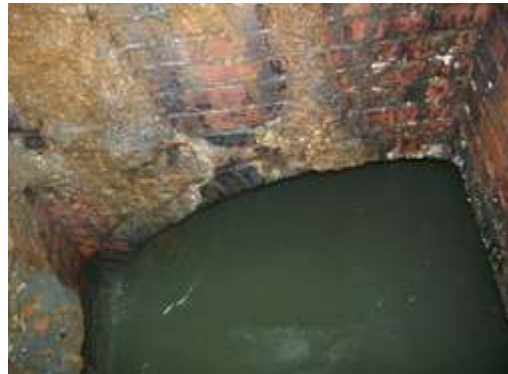
Defect 3

Condition: ☐ Sound ☐ Cracked ☐ Root Intrusion ☐ Loose Brick ☒ **Deteriorated**

DETERIORATION/ENCRUSTATION OF BARREL BRICKS

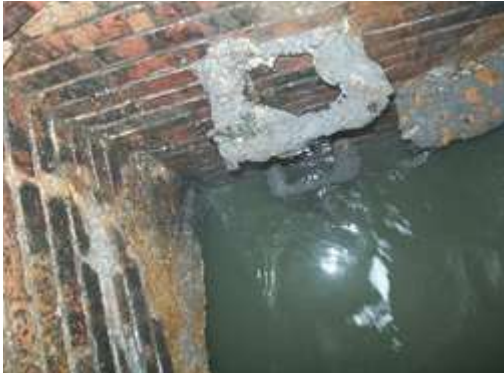
Defect 2

☒ **Evidence Of Surcharge**

EVIDENCE OF SURCHARGE

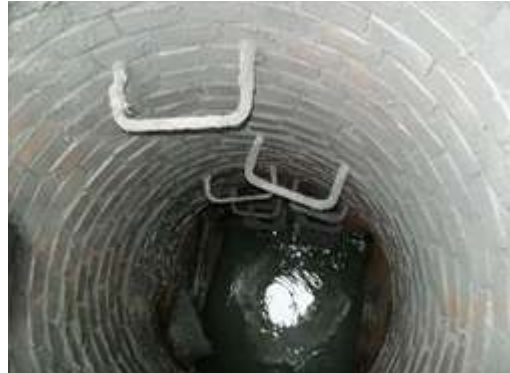
Defect 1

Count: **5** Missing: **4** ☒ **Corroded**

CORRODED AND MISSING STEPS

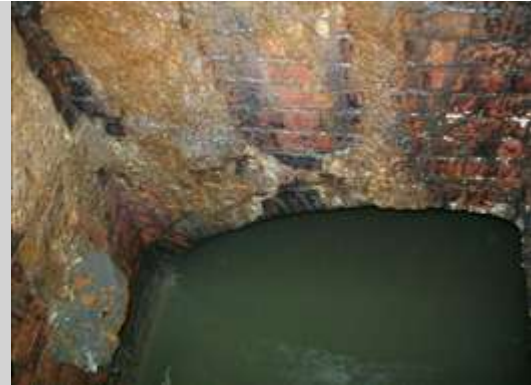
12 O'Clock Outflow

66 in. Circular Gravity Sewer
Pipe Out @ 12 O'Clock

Pipe Height: **66** (in.) Rod and Bar (Angled)
Pipe Material: **Concrete** ☐ Pipe Lined
Invert Depth: **18.20** (ft.) Flow Characteristics: **Fast**
Deposits: ☐ None ☐ Mud ☒ Sludge ☒ Debris ☐ Grease
Silt Depth: **10** (in.) Deposits Extent: **Light**
Infiltration: **None** Pipe Seal Cond: **Sound**

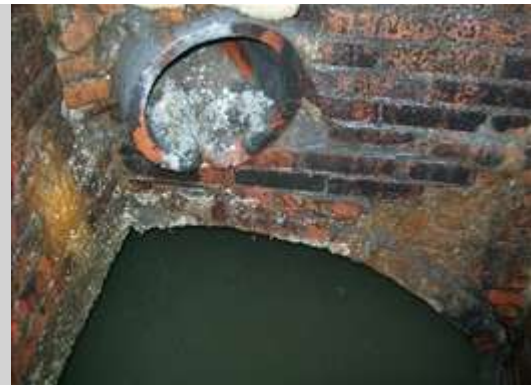
5 O'Clock Inflow

15 in. Circular Gravity Sewer
Pipe In @ 5 O'Clock

Pipe Height: **15.6** (in.) Rod and Bar (Angled)
Pipe Material: **Clay** ☐ Pipe Lined
Invert Depth: **11.40** (ft.) Flow Characteristics: **Slow**
Deposits: ☐ None ☐ Mud ☒ Sludge ☐ Debris ☒ Grease
Silt Depth: **4** (in.) Deposits Extent: **Medium**
Infiltration: **None** Pipe Seal Cond: **Sound**
